TECHNICAL ASSISTANCE TEAM FOR EMERGENCY RESPONSE REMOVAL AND PREVENTION
EPA CONTRACT 68-01-7367

TAT-05-G2-01949

RE: Hendershot and Smith, Inc., Wickliffe, Ohio
TDD# 5-9004-18

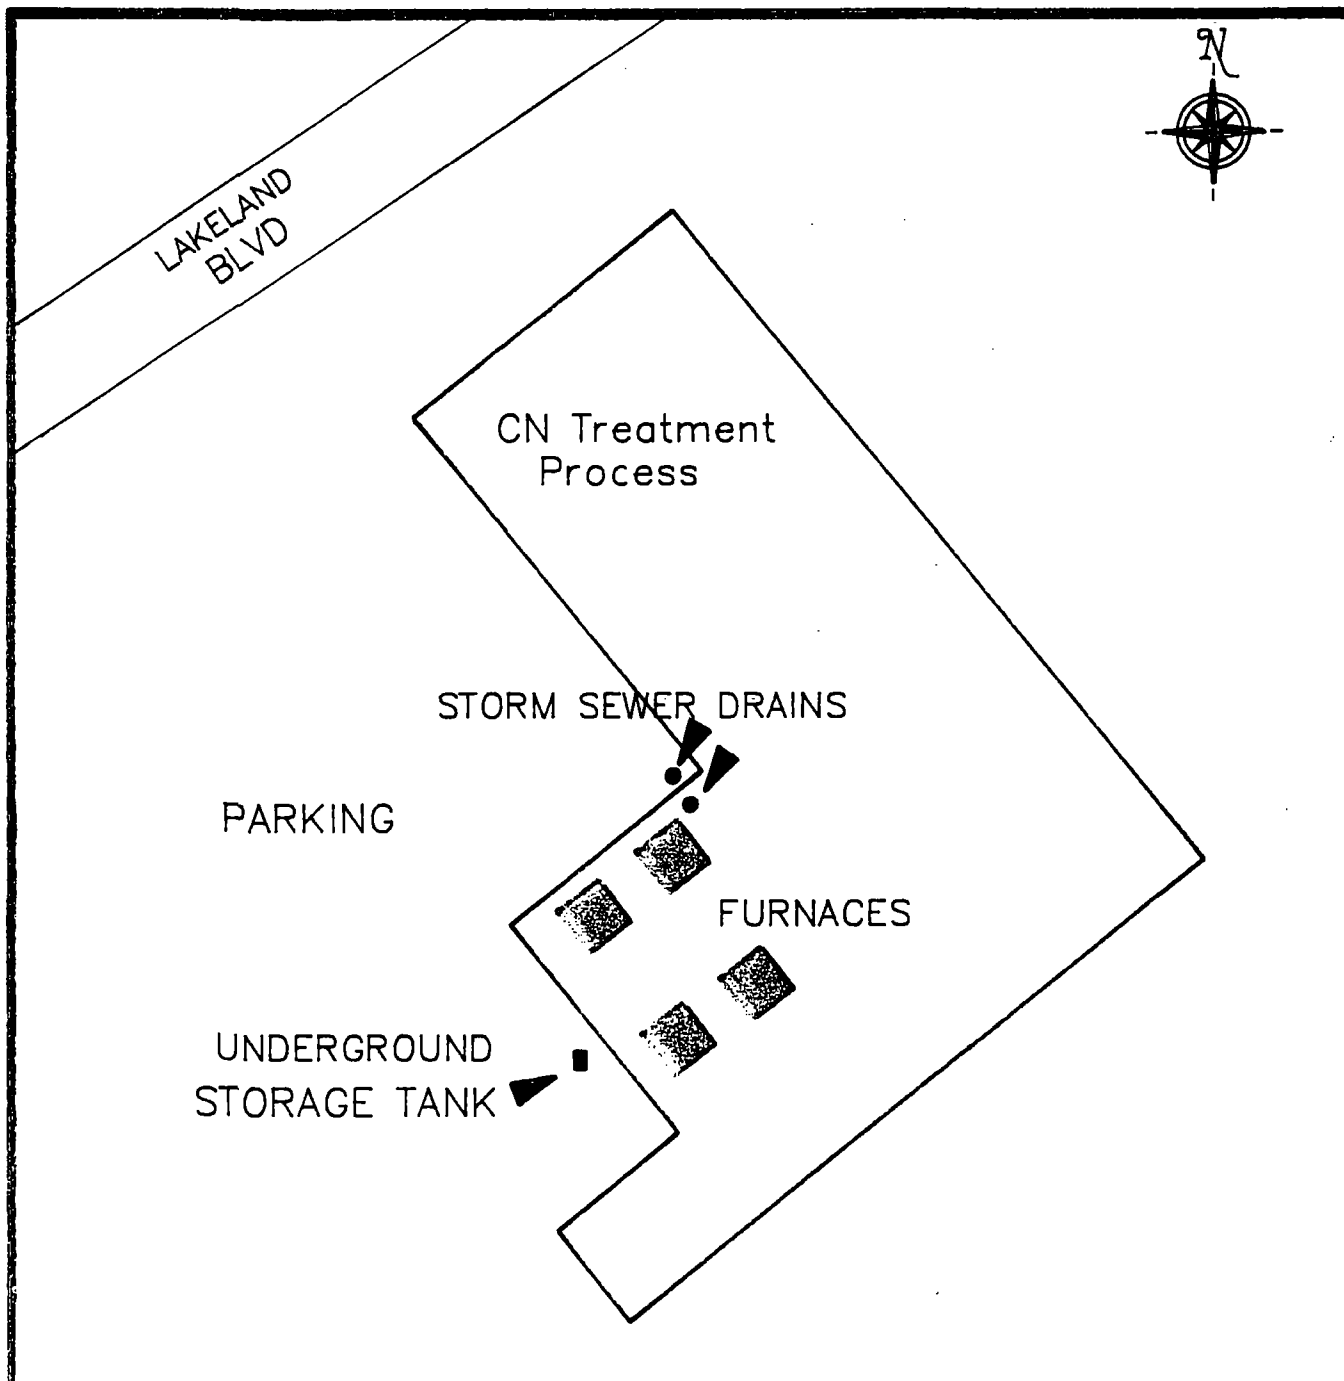
FIGURE 2

Chief Bochenek arranged a meeting with Hendershot and Smith representatives at the facility (Figure 2). Conversation with the company representatives revealed that two separate processes are used at the plant for treating metal parts. One process involves heating metal parts and then cooling the parts in quench oil. The second process at the plant uses cyanide in treating the metal parts, but this process is separate from the heat treating process and does not involve the quench oil.

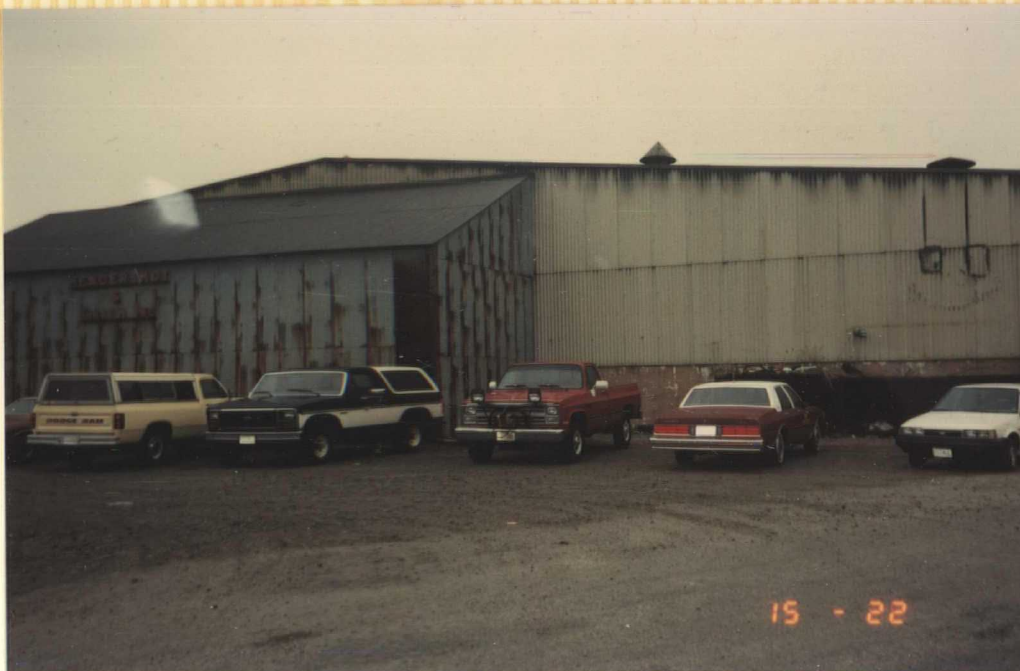
PHOTO: 1 PCS# 2704
 ROLL/PICTURE: 1/11
 SITE NAME: HENDERSHOT & SMITH, INC.
 DESCRIPTION: OUTSIDE VIEW OF HEAT TREATMENT FACILITY,
 PARKING LOT.
 DATE/TIME: 4-20-90 / 1440
 PHOTOGRAPHER: DOOLEY
 FILM: 35MM, 200 ASA, NO ATTACHMENTS

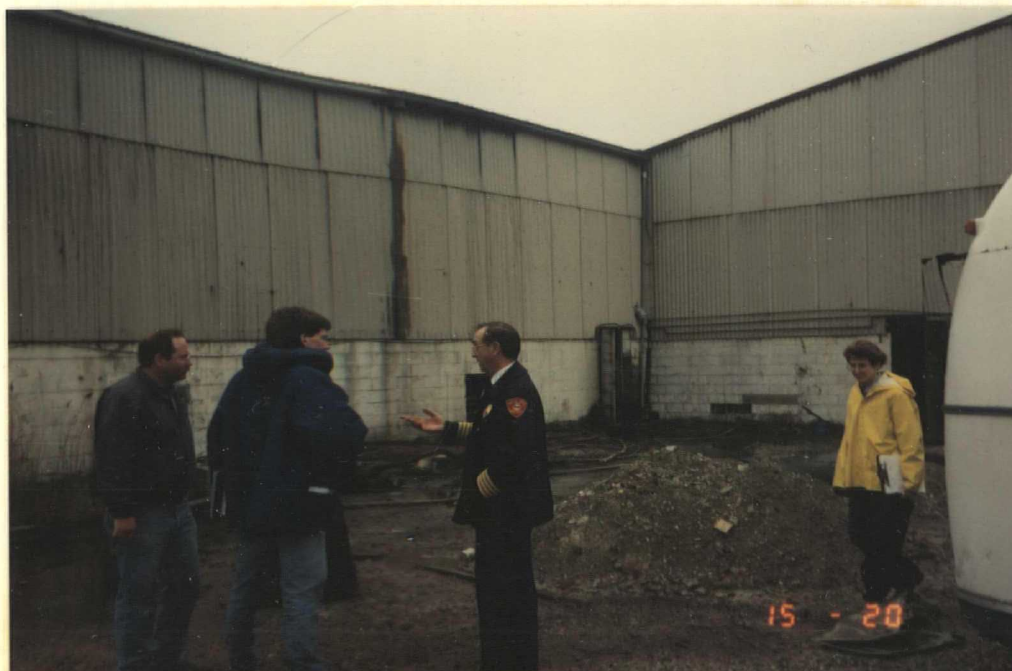
PHOTO: 2 PCS# 2704
 ROLL/PICTURE: 1/9
 SITE NAME: HENDERSHOT & SMITH, INC.
 DESCRIPTION: L TO R TAT MENCIN, OSC RENNINGER, CHIEF
 BOCHENEK (WICKLIFFE FIRE DEPT), TAT FINCH.
 DATE/TIME: 4-20-90 / 1435
 PHOTOGRAPHER: DOOLEY
 FILM: 35MM, 200 ASA, NO ATTACHMENTS
